DOT/FAA/AM-10/5  
Office of Aerospace Medicine  
Washington, DC 20591

# **Evaluation of the Effects of Hydrogen Peroxide on Common Aircraft Electrical Materials**

March 2010

Final Report

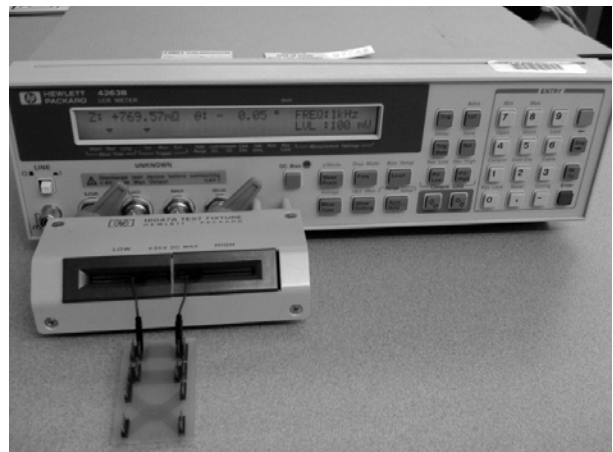
**Figure 2:** Test Setup for Dummy Boards

In order to study different characteristics, tests were performed on several different dummy circuit board layouts, active board, and aviation wire. The three dummy board layouts were wire, interdigitated, and pad. The wire board layout shown in Figure 1(a) was used to test the effects of VHP® on the impedance of traces. The interdigitated board layout shown in Figure 1(b) was used to test how VHP® affected the impedance between traces. The pad board layout shown in Figure 1(c), was used to test the effects of VHP® on pad impedance. A board with active component (microcontroller) was designed to test the effect of VHP® (Figure 1(d)). Aviation wire was also used in our tests (Figure 1(e)). A HP4263B Inductance, Capacitance, and Resistance (LCR) meter (Figure 2) was used to measure the impedance of the traces on each board. For the wire boards, the impedances of all 16 traces were measured at 100mV, 1kHz. For the interdigitated boards, the impedances were measured at 100mV, 1kHz, and 10kHz. For the pad boards, the impedances were measured at 100mV, 1kHz. Figure 2 shows the test setup.
